PROBABILITY OF DETECTION STUDY ON IMPACT DAMAGE TO HONEYCOMB COMPOSITE STRUCTURE USING THERMOGRAPHIC INSPECTION

Andrew J Hodge and James L Walker II
Damage Tolerance and Assessment Branch, Marshall Space Flight Center

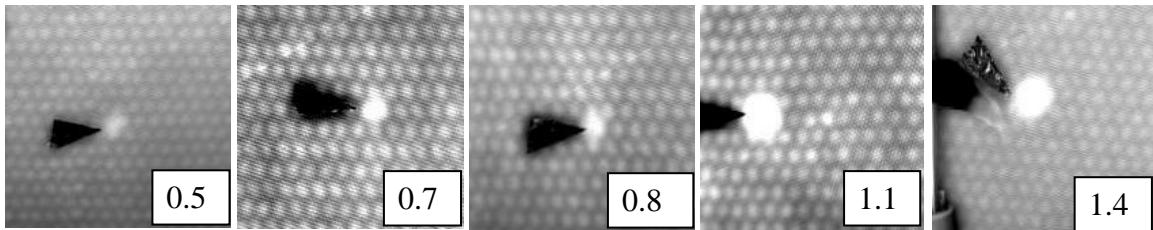
Figure 4. Thermography images labeled with impact energy (Joules)

2.1 Thermographic Inspection. Following impact testing, two NDE technicians independently performed thermographic inspection on the intertank. Thermography was performed with a FLIR Pheonix with 25 mm lens using Thermal Wave Imaging software. None of the impacts of 0.4 Joules or smaller were detected, half of the impacts of 0.5 Joules were detected, and all impacts of 0.7 Joules or greater were detected. A 90/95 probability of detection for impact energy is 0.62 Joules (Figure 3). Figure 4 contains typical thermography images of indications at various impact sites.

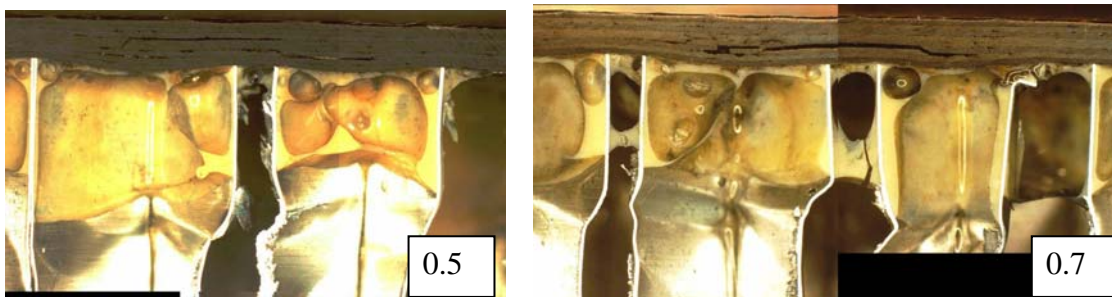
Figure 5. Cross Section of Specimens Impacted with 0.5 and 0.7 Joules of Energy.

Cross sectional analysis indicated that facesheet delamination began at a threshold of 0.5 Joules. Although, core crushing was evident at lower impact energies, the threshold of NDE detection began with the onset of delamination. Figure 5 shows the threshold of delamination and illustrates the core crushing.

One observation noted during the cross sectional analysis was the high level of drupe resulting in facesheet dimpling and porosity over individual core cells. While the thermography was able to find delaminations close to the threshold of delamination

initiation, a higher quality composite facesheet (reduced porosity and dimpling) would likely result in improved NDE detection capability.

No attempt was made to evaluate the damage tolerance of the composite structure. The damage resistance appeared quite low, with impact energy of 0.5 Joules causing core crushing and delamination. However, no strength testing was performed to evaluate the mechanical effects the damage had on the structure.
